## SOME DEFECTS IN VENEER AND PLYWOOD

K.S. Ho

*Forest Research Institute Malaysia*

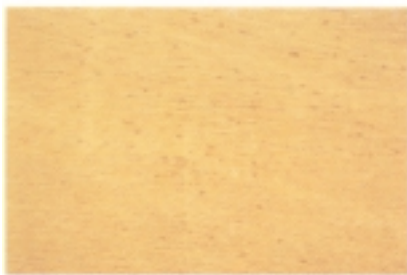
**Figure 1.** *Irregular grain* - grain that is not straight because of the abnormal structure of the wood

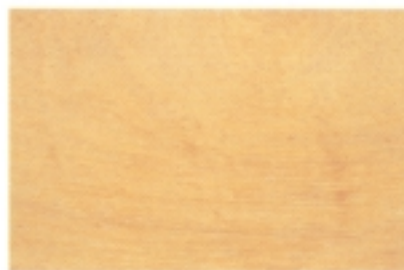
**Figure 2.** *Burl* - a swirl or twist in the grain of the wood resulting from cutting through a contorted or gnarled growth, which usually occurs near a knot but does not contain a knot

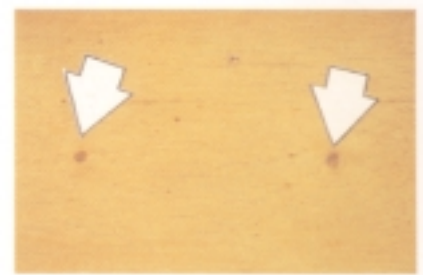
**Figure 3.** *Pin knot* - intergrown knot of not more than 3 mm in diameter

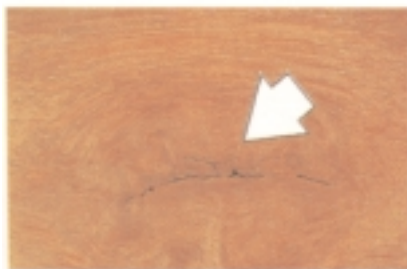
**Figure 4.** *Dead knot* (non-adhering knot) - knothaving fibres intergrown with those of the surrounding wood to the extent of approximately 75% and 25% of its cross-sectional perimeter

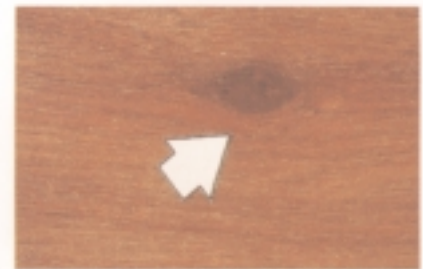
**Figure 5.** *Sound knot* - knot free from rot, solid across its face and at least as hard as the surrounding wood

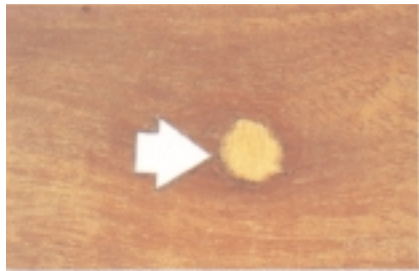
**Figure 6.** *Knot hole* - hole caused by removal of a knot

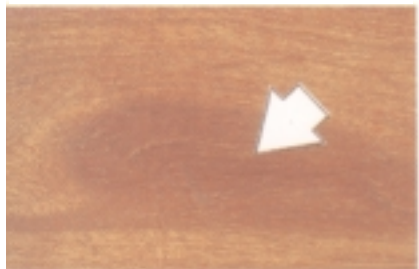
**Figure 7.** *Included phloem* - strands or zones of abnormal and often very hard tissue occurring in long or short concentric arcs in some timbers, caused by abnormal development of the cambium

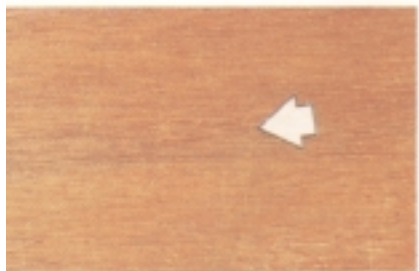
**Figure 8.** *Compression failure* (cross-break, lightning shake, deprecated) - deformation or fracture of the fibres across the grain resulting from excessive compression in the direction of the grain either by direct end compression or in bending

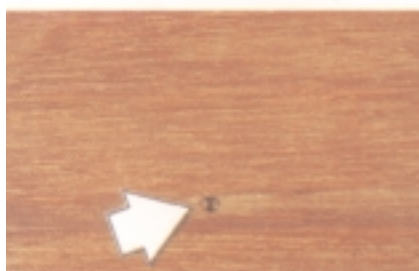
**Figure 9.** *Worm hole* (borer hole, shot hole, grub hole) - hole or tunnel or channel caused by a wood borer.

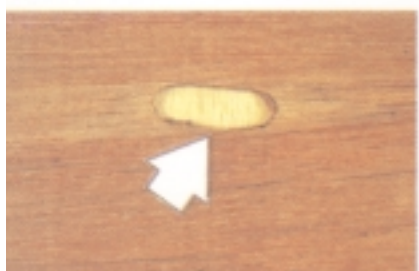
**Figure 10.** *Large worm hole* - worm hole more than 1.5 mm in diameter or a channel made by a wood borer. This includes holes made by marine borers

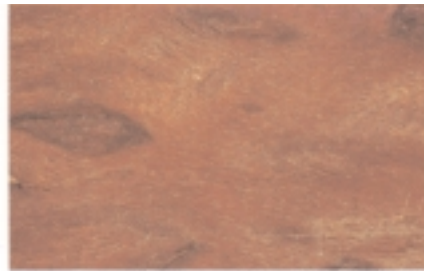
**Figure 11.** *Chicken track* - blemish, mainly in the form of a diamond pattern, occurring on flat-sawn or rotary-cut surfaces some *Shorea* species and due to localised grain distortion believed to result from insect damage to the cambium

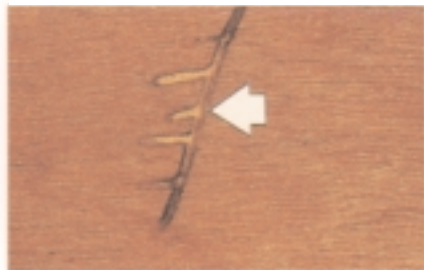
**Figure 12.** *Worm track* - a channel caused by a wood borer

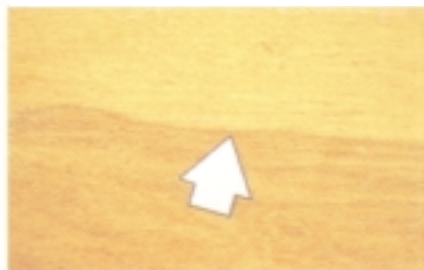
**Figure 13.** *Sound discoloration* - veneer of nonuniform colour resulting from a mixture of sapwood and heartwood, but not stained

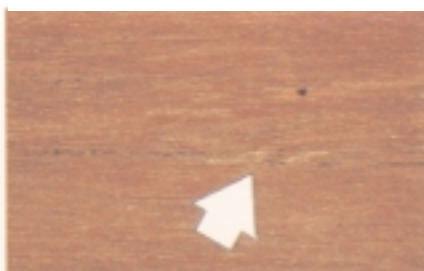
**Figure 14.** *Rot* (decay) - decomposition of wood by fungi or other micro-organisms. This results in softening, progressive loss of strength and mass and often a change of texture and colour

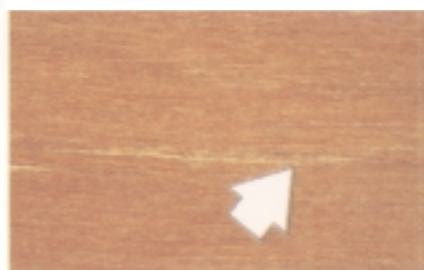
**Figure 15.** *Split* - separation of the fibres along the grain extending through the thickness of the veneer

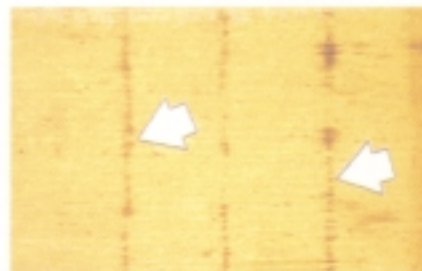
**Figure 16.** *Oil stain* (equipment stain) - stain of the outer ply caused by dripping of oil or by contact with the oily surface of equipment

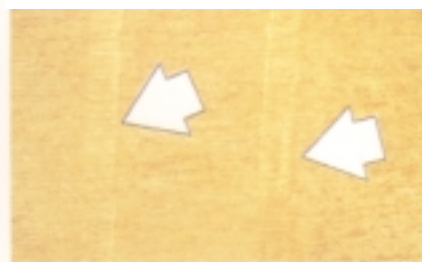
**Figure 17.** *Chain mark* - local depression on the outer ply caused by the conveyor chain

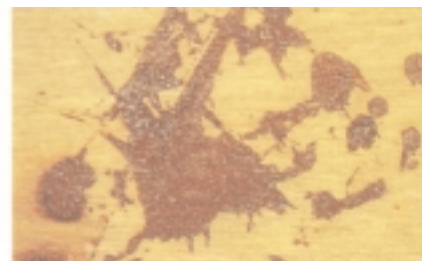
**Figure 18.** *Glue smear* - blemish that has been caused by glue splashed on the surface of veneer

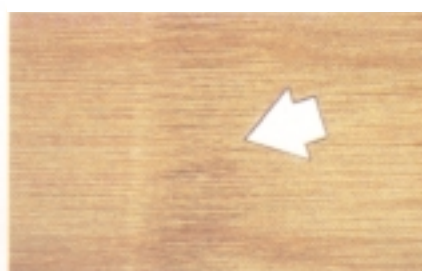
**Figure 19.** *Sander burn* - burnt mark on the outer ply caused by excessive friction during sanding

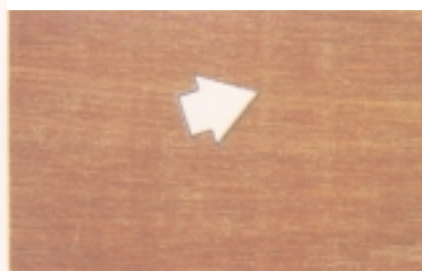
**Figure 20.** *Knife mark* - fine and shallow groove running the whole width of the panel surface caused by a nick on the knife edge
